MAGISTRATES COURT *of* TASMANIA

Record of Investigation into Death (Without Inquest)

I, Robert Webster, Coroner, having investigated the death of Daniel Thomas Knight

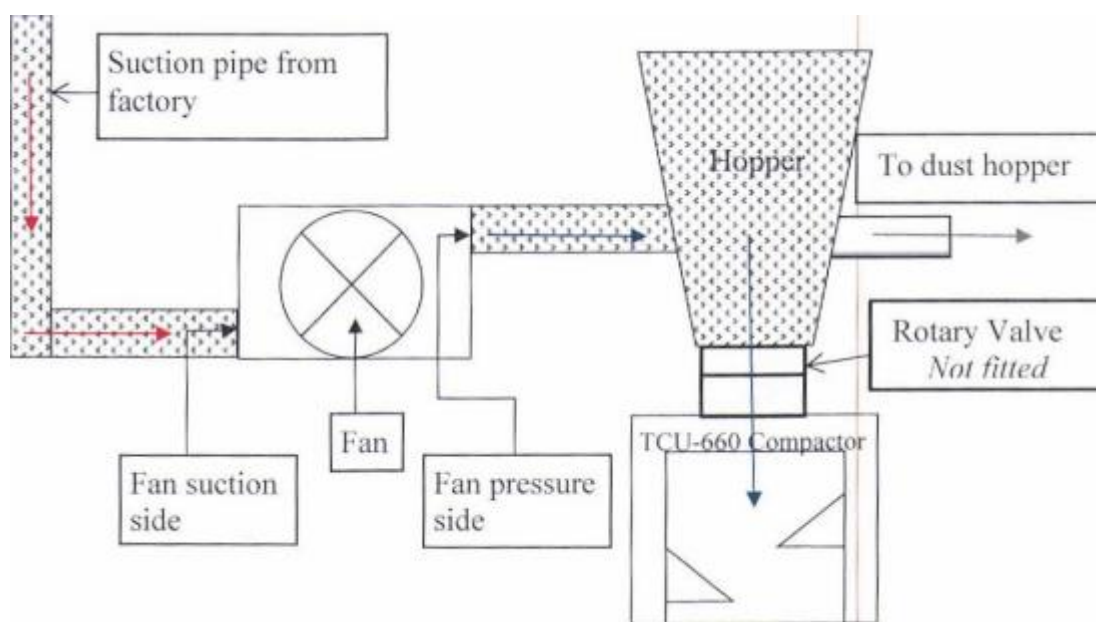
The paper trim extraction system implemented by WVP consists of a large, enclosed fan with a suction pipe and a pressure pipe. The suction pipe collects the trimmed paper from the area on the book assembly line where it is cut and transports it through the metal ducting to a point where it is transferred to the pressurised side which is connected to a large hopper where the paper is collected. The fine paper dust which is associated with the trimming process is then removed and carried into another hopper and the paper waste falls through a shoot from the bottom of the hopper into the compactor where it is compacted into a 660 L portable wheelie bin. The system is depicted in the following diagram:

The paper trim extraction unit was examined by Bruce and James Woolston in England and purchased along with the binding line. When set up in England it was coupled with a rotary valve that was positioned just under the collection hopper and above the compactor. The paper would be delivered into the compactor through the rotary valve from the hopper. The purpose of the rotary valve was to ensure air pressure in the compactor was at an atmospheric level and not at the same pressure as inside the hopper which was pressurised from the fan delivery system. Without the rotary valve, air pressure in the compactor would cause the trimmed

“I can also see why the company have been experiencing problems in the operation of the system because it appears to have been incorrectly installed. There should have been a device to stop the air from blowing down into the compactor. This would be done with either an air balancing fan on the clean (exhaust side) of the dust filter or alternatively with a rotary airlock between the air separator and the compactor. As far as I can see from your photos neither of these devices have been fitted, therefore the compactor would have been operating in a pressurised condition which would lead to all sorts of problems...”

Had a properly installed rotary valve or airlock or air balancing fan been installed then the CU would not have been jammed, it would not have required unblocking and it follows therefore Mr Knight would not have entered the CU. Approximately every 10 minutes or so the CU had to be unblocked²⁵.

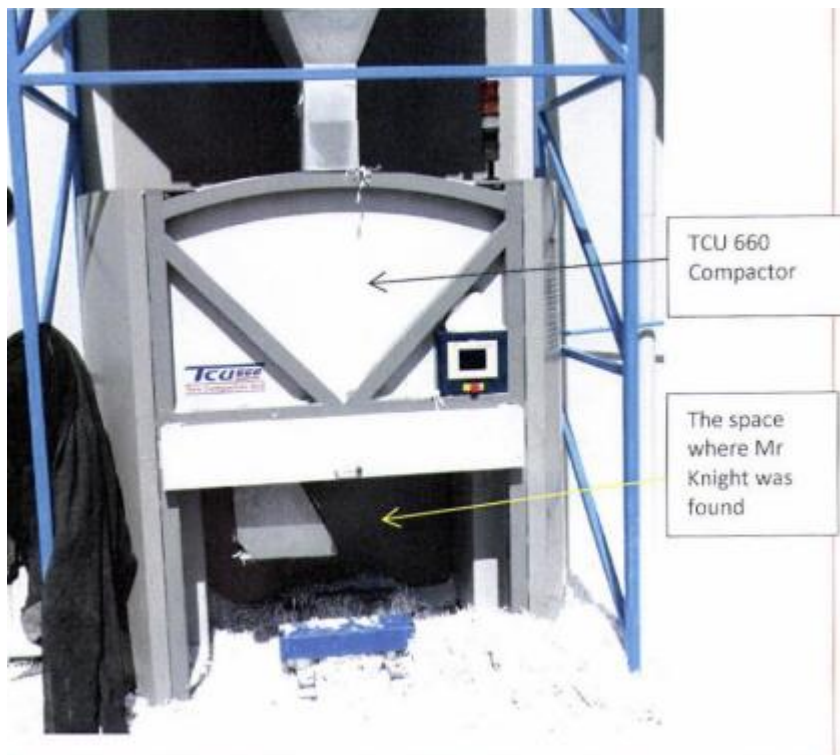
The CU had a normal 3 pin 240 V electrical connection which was plugged into a 240 volt power point. The system consisted of an airline which was connected to the compressed air system operating in the factory which was plumbed to a point near the compactor. There was an on/off valve near the compactor.²³ Once a 660 L wheelie bin is placed inside the open space in front of the CU, the bin is raised to form a seal between the compactor and the top of the bin. The trimmed wastepaper is deposited in the bin. After the bin is positioned and the CU is turned on the left-hand side ram automatically lowers to allow paper to fall through and into the bin. As the paper builds up the compactor senses a level of paper and begins to compress the paper with the two feet, one after the other, until the bin is full. The 5 kN force is applied by the rams to compress the paper. Lights flash and a siren sounds to indicate when the bin is full and needs to be replaced. The compactor is depicted in the photographs as follows:

From the time the paper trim extraction unit was installed, and the CU connected by way of the locally manufactured chute from the large collection hopper the rams of the CU became blocked by paper trim which caused the CU to stop working.²⁴ As to why this occurred the manufacturer of the trim extraction unit, Integrated Air Systems, advised WST of the following:

The report from Sage Automation indicates the engineers who prepared that report found electrical power and air pressure could not be isolated on the CU unit itself. The CU was not being used at the time of this accident and Mr Green says the air was turned off and the power switch was off at the power point but an out of service tag had not been placed on the hose and the electrical supply.²⁶ However as indicated on page 6 when Mr Green went to turn the air on to the compactor so that he could assist Mr Knight he found it was already turned on and Mr James Woolston recognised the screen of the compactor was on which means the power was connected. ²⁷ Sage Automation determined the right-hand side ram was leaking air, when the mains supply was turned off and this caused it to creep down overnight. This would have required WP to either place some shoring underfoot to support it to prevent it from lowering or keeping the air supply on so the operator could raise the foot as necessary. It appears from the evidence the air supply was kept on. There is no evidence on file that WP implemented an isolation procedure in respect of the CU.

Sage Automation also found there was no interlock which prevented motion of the rams on opening of the front guard. The report indicates new motion commands were not triggered by the control system during tests but stored pneumatic energy was not dissipated on opening of the guard. This is particularly hazardous in situations when a ram is jammed or otherwise stuck. In addition the emergency stop button was not safety rated and was not wired into the machine pursuant to the design drawings although it was wired to release all air pressure when pressed. Accordingly it was not interlocked to the front guard. In addition it was not interlocked to any other components of the machine and therefore when the button was reset the machine was fully functional again rather than having to reset the machine from a master control via the programmable logic controller (plc).

Finally a vinyl strip had been taped as a flap covering the LCD screen of the control panel located on the front of the CU. The LCD screen permits the user to set the CU in motion or to control its functions. When electricity is turned on the screen lights up and provides a user access to the functions. When electricity is turned off the screen is blank. This vinyl strip may have prevented Mr Knight from seeing the electricity to the CU was turned on. He knew from what he had been told it had been turned off and was out of action. He had also seen Mr Green get inside the CU on a number of previous occasions in order to clear the paper³³.
