MAGISTRATES COURT of TASMANIA

RECORD OF INVESTIGATION INTO DEATH (WITH INQUEST)

Christopher William WAGG

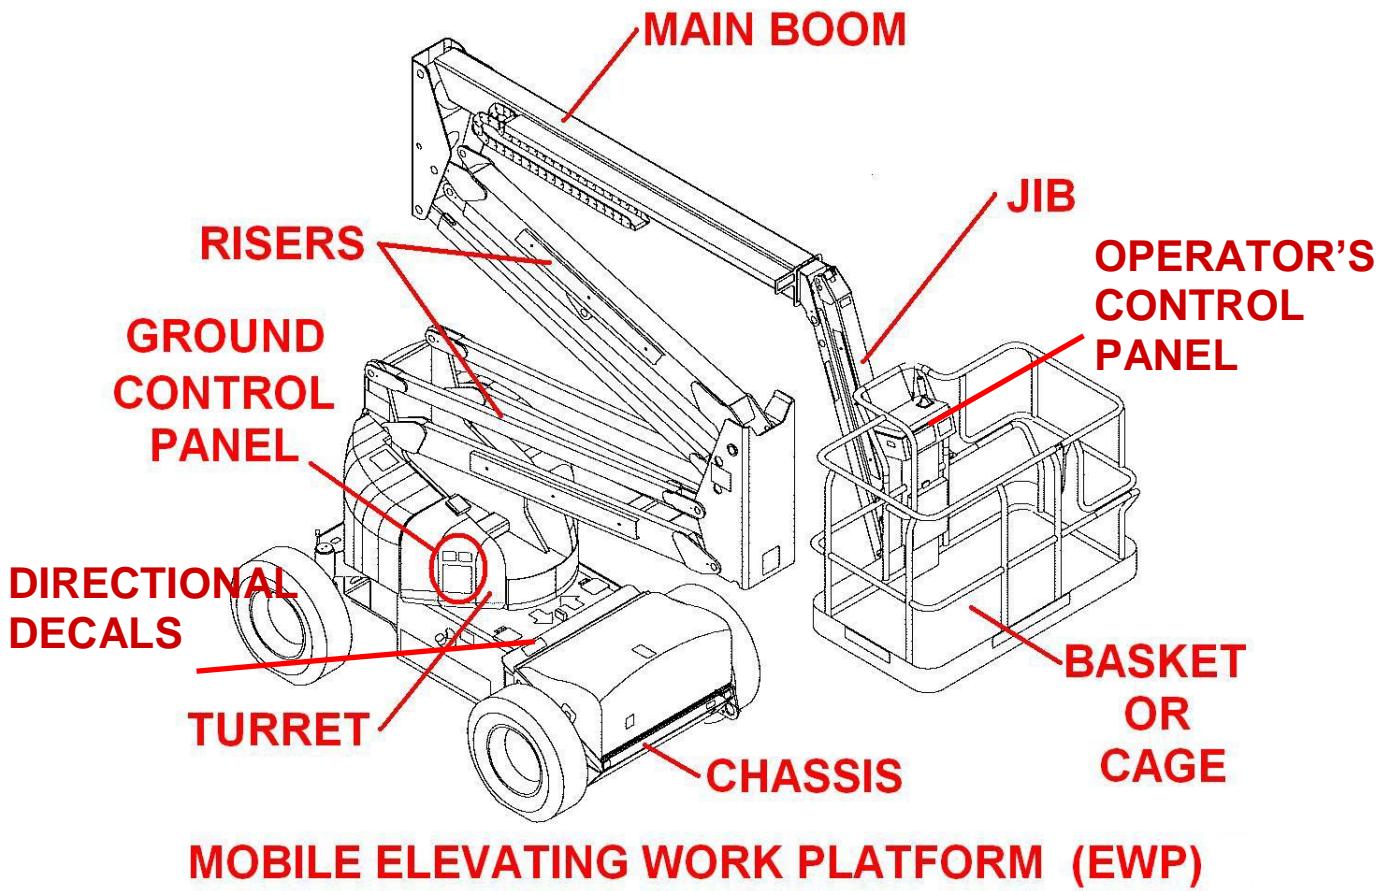
36. The particular type of EWP that Mr Wagg was using at the time of the accident on 3 August 2009 was an Upright AB46D model. This indicates it has a maximum reach of 46 feet (14.02 metres) and is diesel powered. The serial number is 1104.

37. A diagram of the AB46D Mobile Elevating Work Platform when in its normal driving position is depicted below.

39. Of particular significance in the inquest was the absence of directional markings on the EWP. These enable the operator to ascertain the direction that the EWP will travel in response to engaging the controls. They are most important because the turret of an EWP may be rotated or “slewed” around 180° so that the controls for direction of travel are reversed. Three sets of directional markings should be present.
